March 28, 2016

Re: Structural Condition Survey
Altmyer Barn
KSS No. 16052

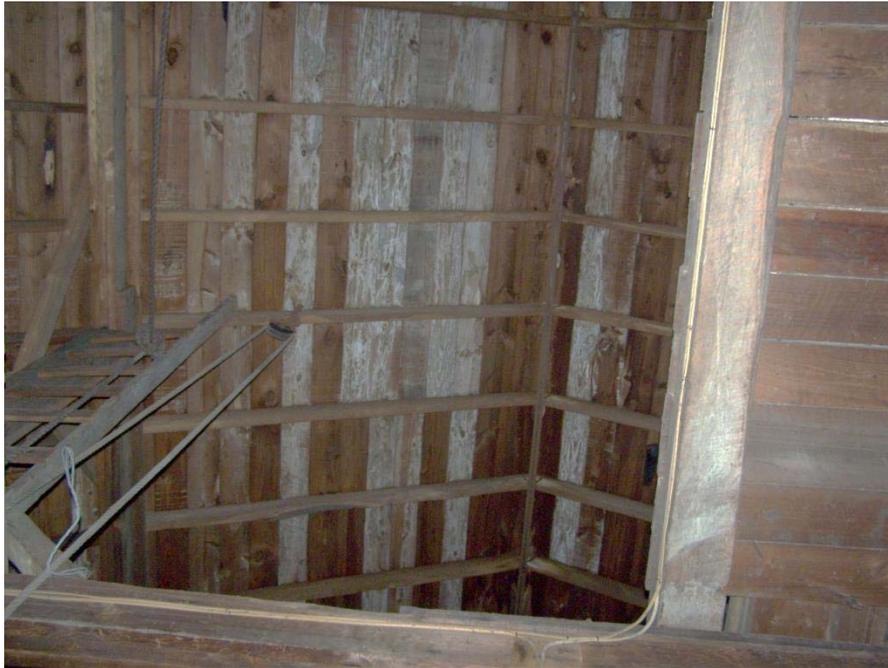
I observed 4 buildings. Building 1, the barn is a two-story structure with a generally rectangular footprint of about 50 ft. by 32 ft. It is a wood, timber framed structure. Although old, the building is in relatively good condition. The roof is much higher than the first floor, so, I couldn't see the structural members up close. Nevertheless, I didn't see any major defects or anything that caused me concern.

Photo 1 – Barn Roof Structure

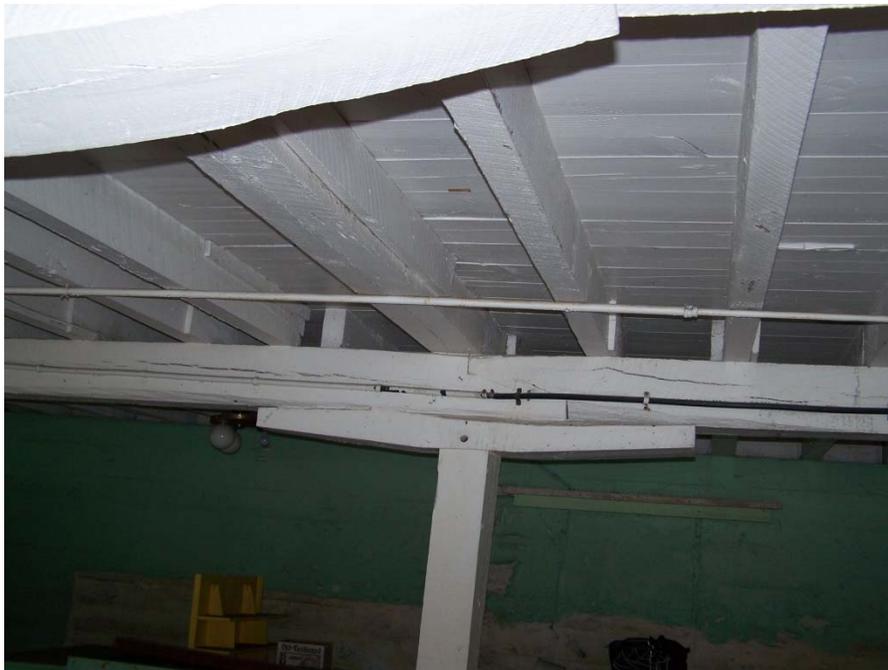
Photo 2 – First Floor Framing

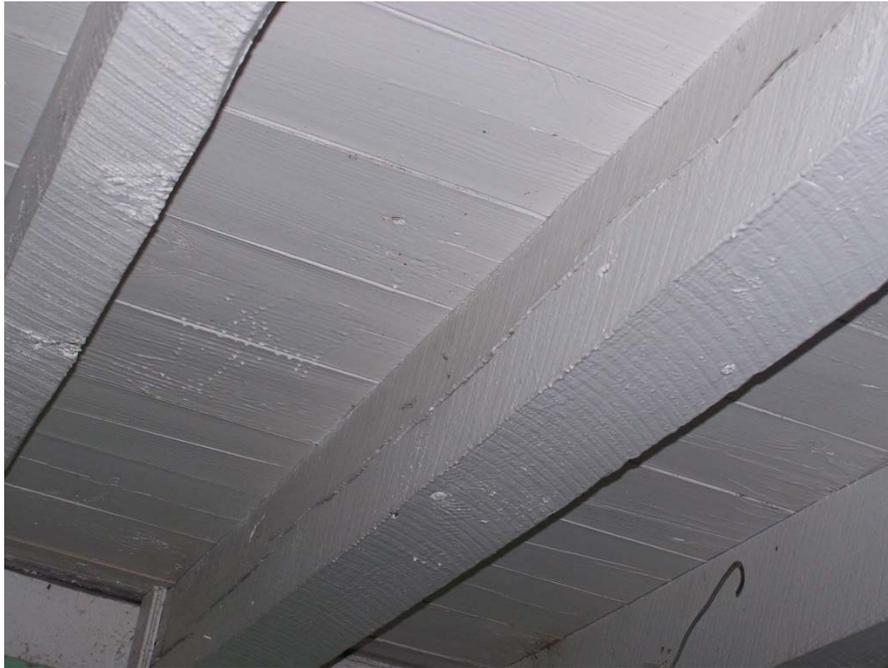
While standing in the basement, I could see the first floor framing much better. Again, I didn't see any major defects, but, I did see about 8 wood beams that are cracked. See Photo 3 of Appendix One for a typical condition. This is likely due to the age of the building rather than the members being overloaded. In fact, according to my preliminary calculations, the floor structure is adequate to support at least 100 PSF, which is more than enough for use as a gathering space. Additionally, given its past use, the floor structure likely supported more weight than is required by code for a gathering space. However, I do recommend that the cracked beams be repaired prior to using this as a gathering space. The repair involves injecting wood glue into the cracks.

Photo 3 - Crack in First Floor Beam

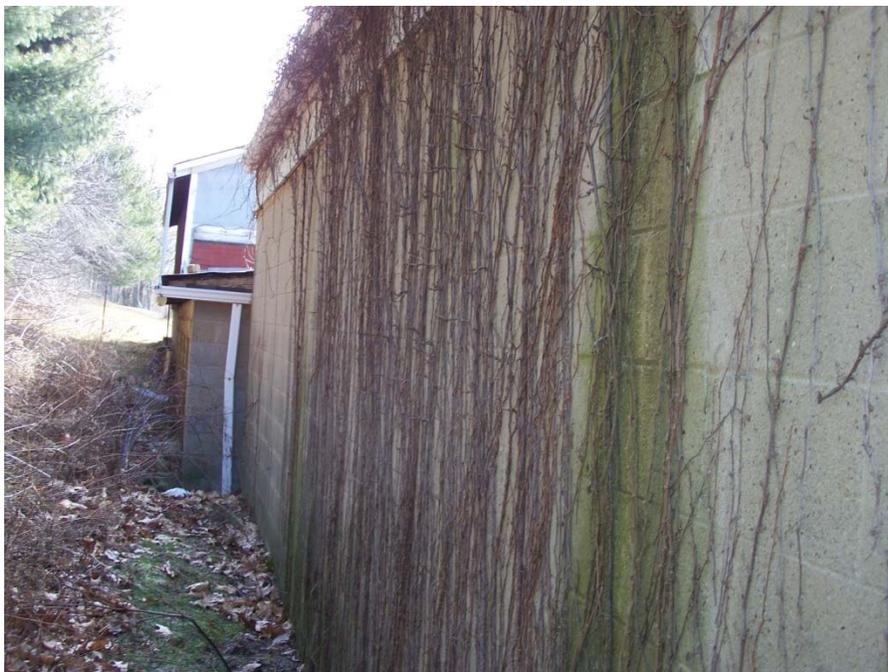
covered. Building 3 is an open structure with no wall on the south side. I didn't see any concerning deterioration of Building 2 except for vegetation growing on the north wall.

Photo 4 - Vegetation on Back of Bldg. 2

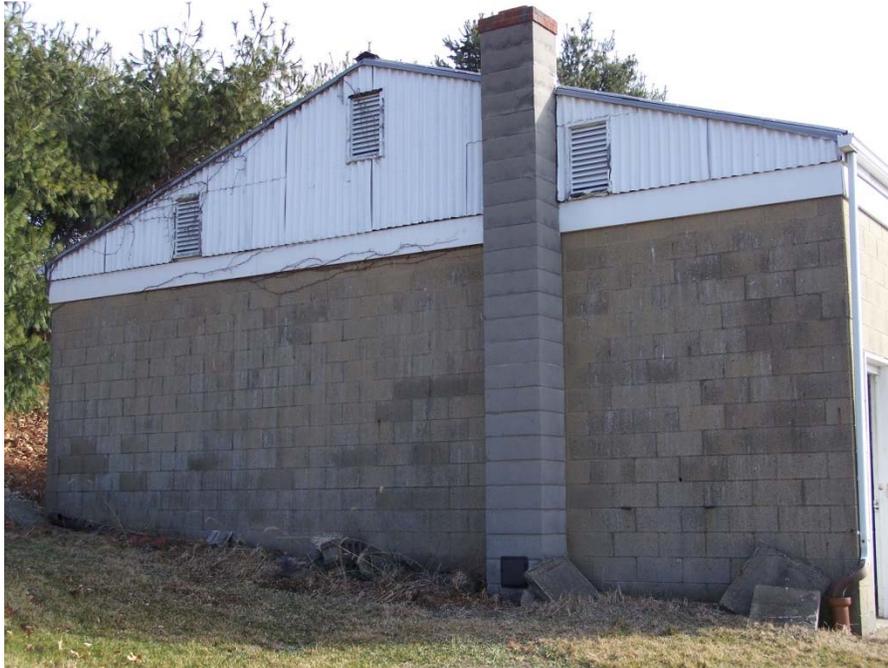
Photo 5 – West Wall of Bldg. 2

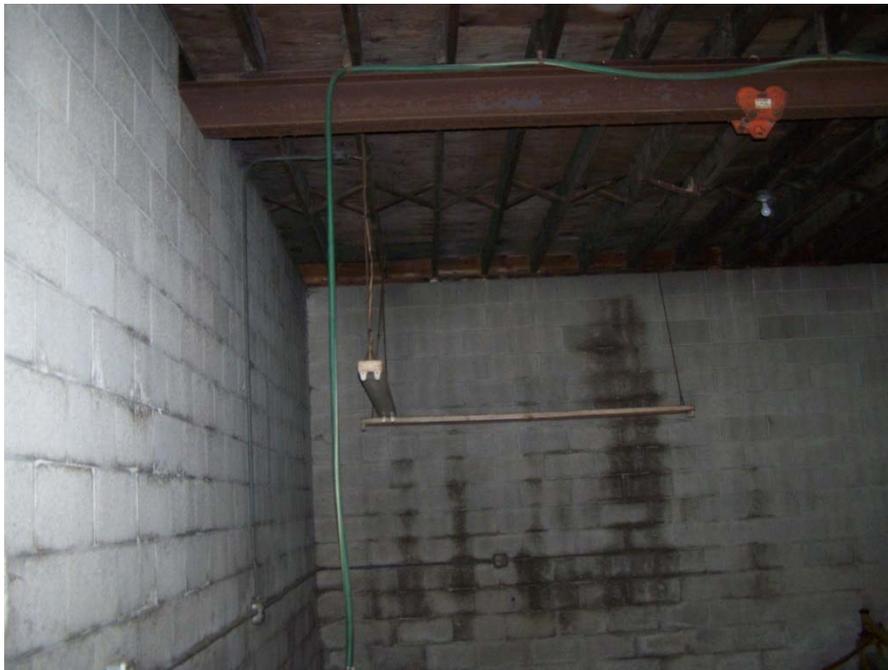
Photo 6 – Wood Roof Framing of Bldg. 2

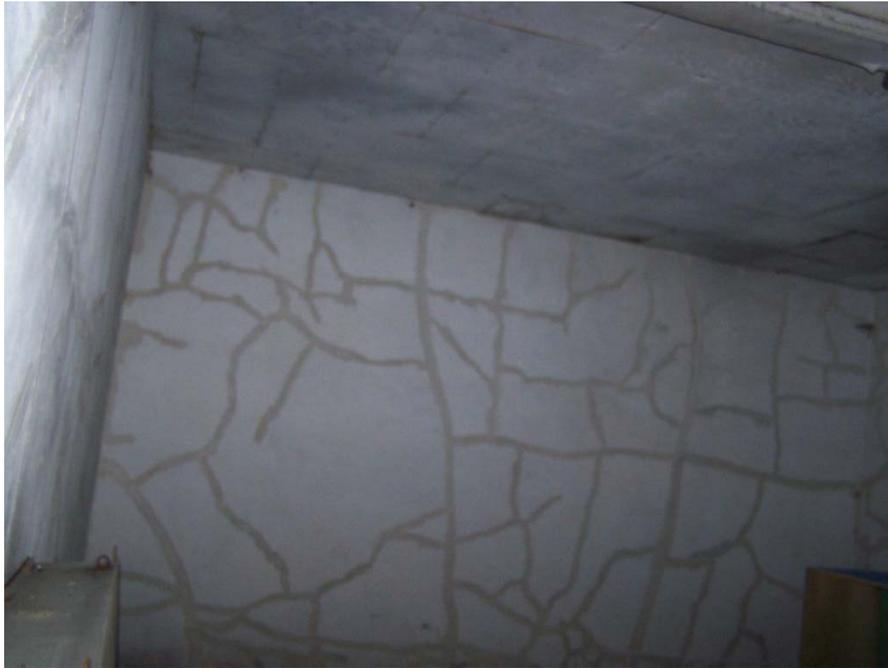
Photo 7 – Structure Covered – Bldg. 2

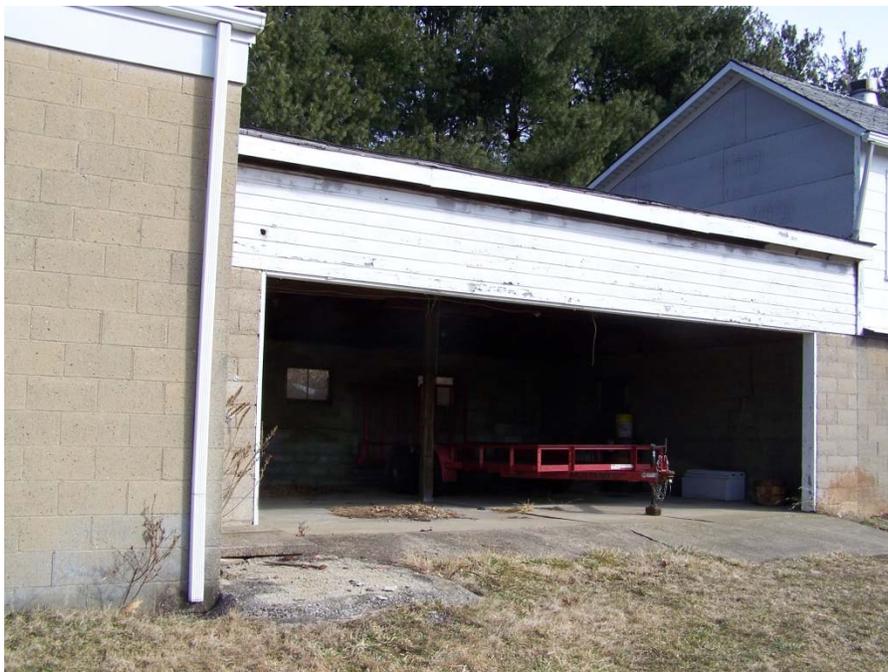
Photo 8 – Open South Wall – Bldg. 3

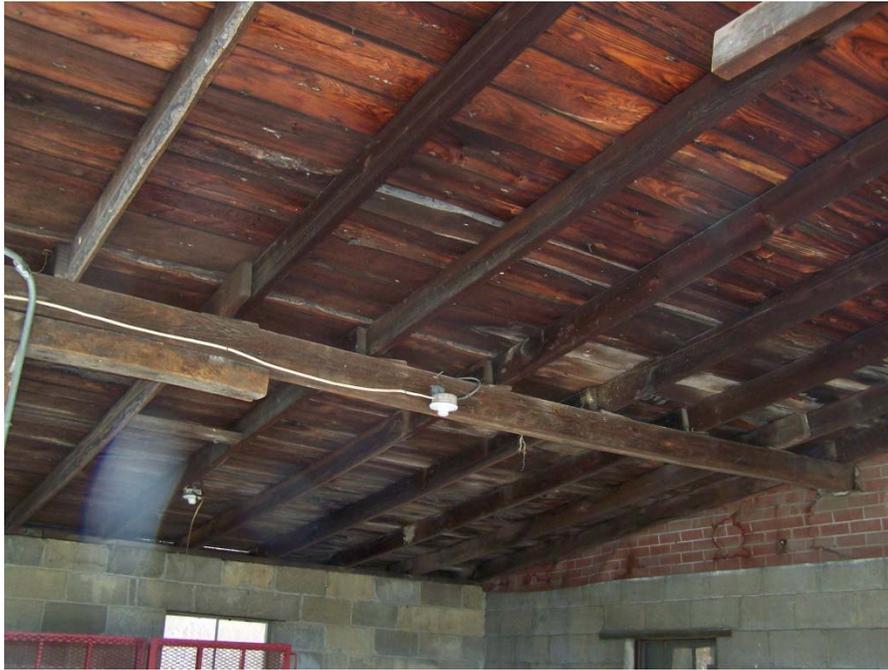
Photo 9 – Wood Roof of Bldg. 3

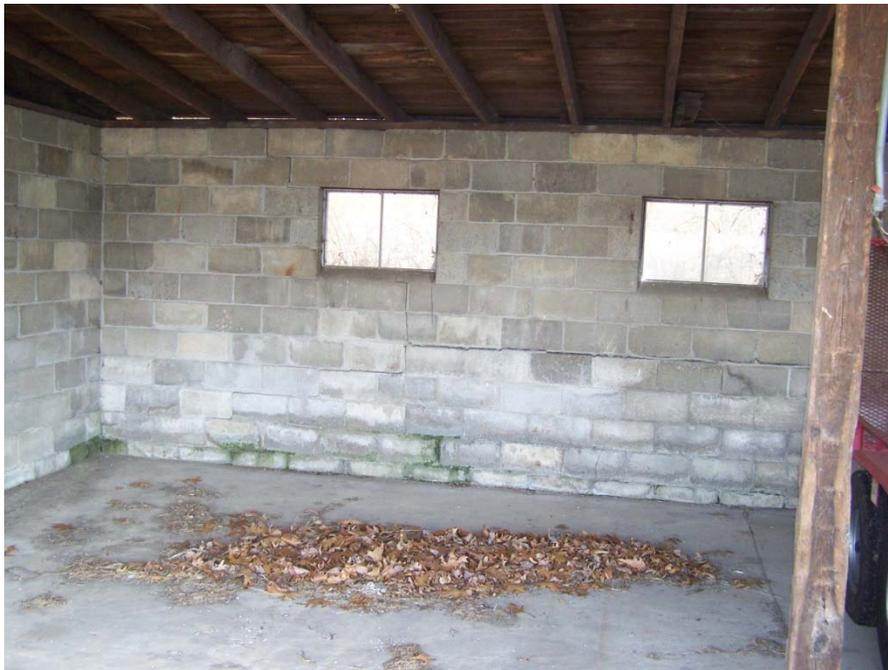
Building 3 has a large vertical crack in the east side wall and horizontal crack in the back north wall. See Photos 10 and 11. The walls are above grade, so, the only load on the walls is wind. It is likely that the cracks formed because of building thermal movements and worsened due to freeze/thaw cycles. The cracks can be repaired by repointing. However, if the areas re-crack, then, more substantial repairs may be needed.

Photo 10 – Horizontal Crack – Back Wall of Bldg. 3

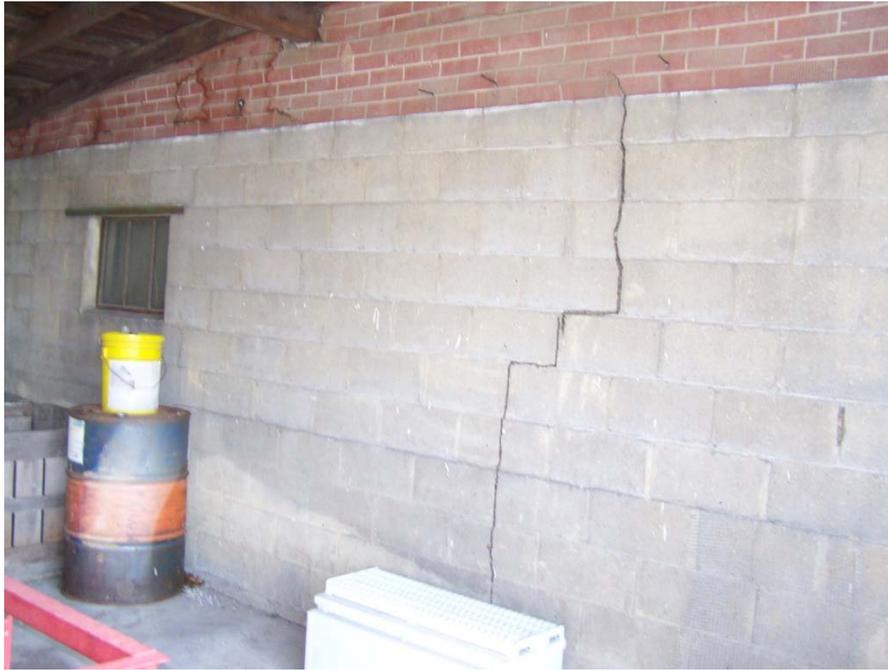
Photo 11 – Vertical Crack – Side Wall of Bldg. 3

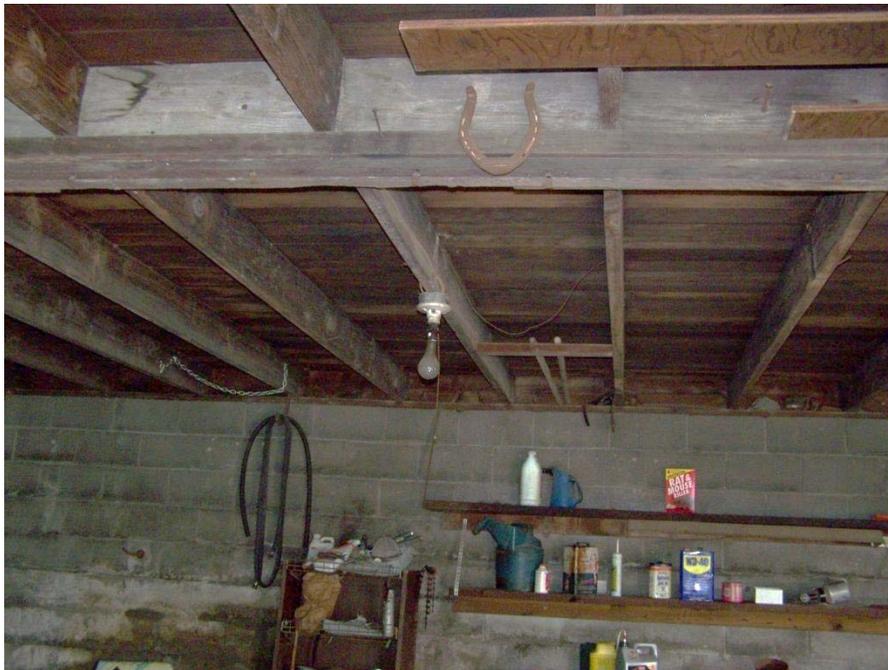
Building 4 is a two-story structure with a footprint of about 39 ft. by 22 ft. This building has perimeter masonry walls with interior wood framing. Although I didn't see any concerning deterioration, the second floor structure is relatively skimpy. The floor structure consists of 2x8 at 24" and spans about 11'-6". The calculated live load is only about 20 to 25 PSF, rendering it relatively useless.

Photo 12 – Second Floor Framing of Bldg. 4
